HISTORIC PROPERTIES REPORT

YUMA PROVING GROUND

YUMA, ARIZONA

FINAL REPORT

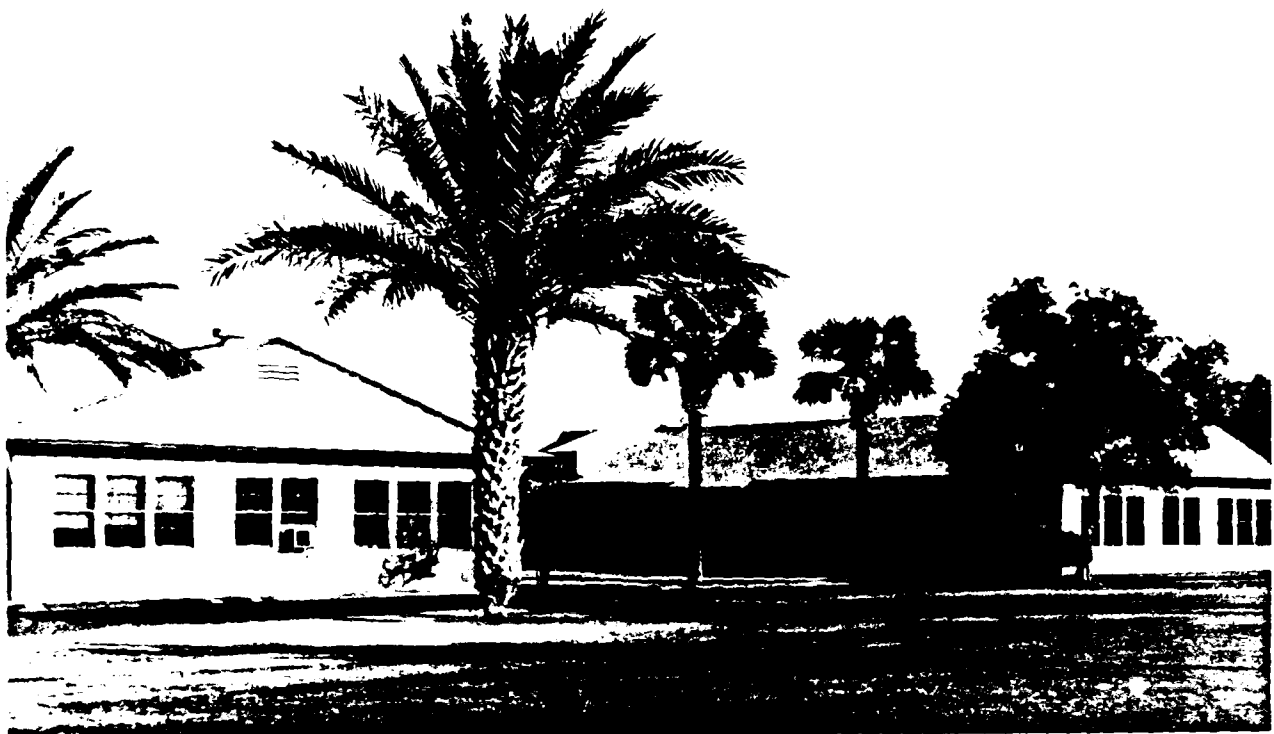
Illustration 6 Post headquarters (Building 2). This structure is from the first group of buildings erected after the Yuma Test Branch was relocated from below the Imperial Dam to its current site in 1947-48. (Source: Field inventory photograph, William A. Brenner, Building Technology, Inc., 1983)

- Post Headquarters (Building 2), a one-story U-shaped wood frame building with a gable roof, stucco exterior, and a continuous pent roof that shades the building's windows. (Illustration 6)

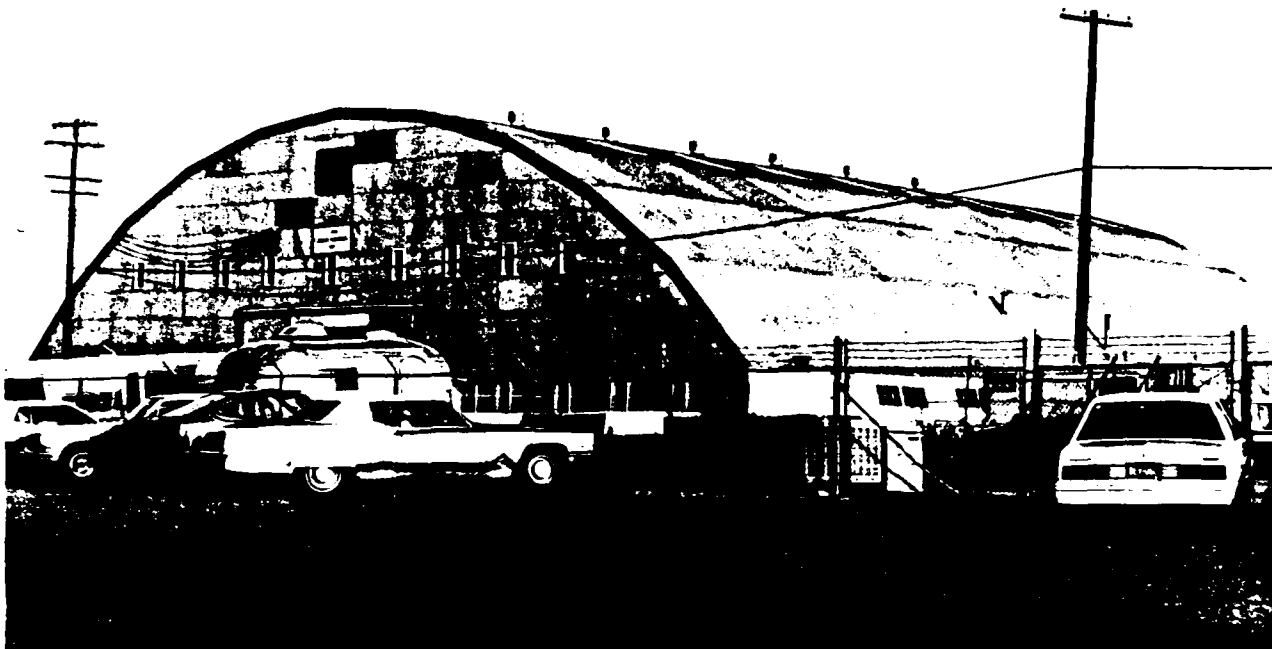
Illustration 9 Vehicle maintenance building (Building 204). The majority of structures located outside the central portion of the Main Post area of the proving ground are metal buildings. This structure, erected in 1954, is one of the oldest. (Source: Field Inventory photograph, William A. Brenner, Building Technology, Inc., 1983)
